Systems Engineering Investigation of Navy Electrical Bomb Fuzing

Gary A. Evans (Naval Air Warfare Center, Patuxent River, Maryland)

The US Navy, in an effort to identify the root cause of dud electrically fuzed bombs, commissioned an electrical fuzing systems engineering evaluation. The study analyzed the electrical fuzing components, their specifications, operating histories, and interaction into the sub systems that comprise the aircraft/weapon electrical fuzing system. Navy experts for each of the components that make up the electrical fuzing systems focused their efforts into a systems engineering analysis vice a component level analysis.

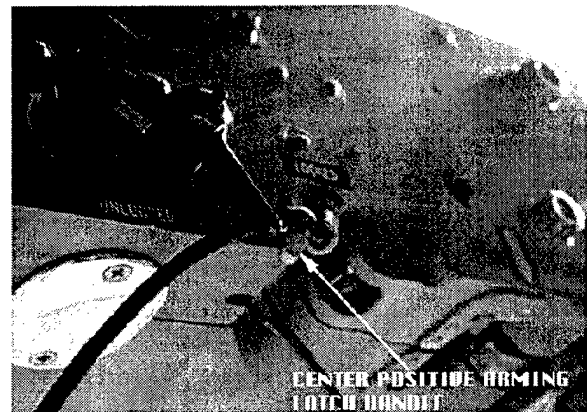
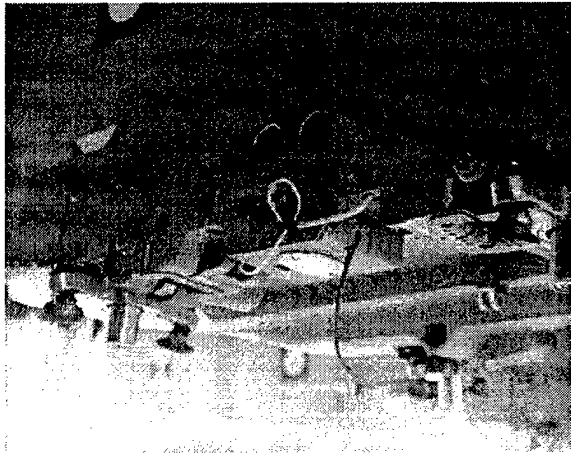
Co-axial cable routing failures were identified during F/A-18E/F Engineering and Manufacturing Development (EMD) weapon separation testing. Post flight suspension equipment inspections found several instances of the Mk 122 co-axial cable returning with the aircraft after a weapon release. Figures 9 and 10 are post flight photos of the BRU-33 loaded on the F/A-18E/F. They identified two failure modes that are applicable only to the BRU-33 and Mk 82/83 bombs. The relative position of the BRU-33 rack lock/unlock handle to the co-axial cable of the Mk 122 coupled with flight air loads on the co-axial cable caused both of these failures. The air loads forced the cable against the side of the bomb rack unit. When the weapon is released the cable becomes hung-up on the bomb rack mechanisms. In figure 9 the cable became

trapped between the rack lock/unlock handle and the positive arm latch handle. This hang-up reduces the effective length of the Mk 122 coaxial cable relative to the lanyard. This failure would significantly reduce the duration of the charge time and may cause a dud bomb. Figure 10 shows a similar but more serious failure mode where the co-axial cable was forced by air loads to loop around the rack lock/unlock handle. This failure would prohibit the fuze capacitor from receiving its required duration charge signal of 15ms and result in a dud bomb. The aircraft contractor performed original weapon integration testing on the F/A-18A. Weapon components such as the Mk 122 were thought to be irrelevant and thus this failure mode was never identified.

Figure 9
F/A-18E/F / BRU-33 Mk-122 Failure

Figure 10
F/A-18E/F / BRU-33 Mk-122 Failure

From careful post flight examination the F/A-18E/F EMD known failure rate for cable hang-up was 2.2% that equates to a 97.0% reliability at a 90% confidence level based on eight recorded failures out of a total of 361 recorded test events. The failures were split evenly between 500 and 1000 lb bombs (4/181 Mk 82 and 4/180 Mk 83). Navy weapon integration standard operating procedures (SOP) increased the chances of finding these failures. After a weapon separation flight, the delivery aircraft was required to directly return for post flight armament inspections. Subsequent data analysis of COPE data has revealed an F/A-18 A-D known failure rate of 1.5% which equates to a 97.8% reliability at 90% confidence levels were based on three failures out of 195 data samples. The failure rate is almost certainly much higher as the evidence is easily lost in flight or on landing. This can be seen by close examination of figure 9. The co-axial cable connector has been extracted from the BRU-33 electrical fuzing connector and is ready to fall out. Therefore, co-axial cable hang-up will cause electrically fuzed bomb failures. This failure mode as stated above is only applicable to the CVER with Mk 82 and Mk 83 bomb bodies. Mk 82 and Mk83 JDAM mounted on the BRU-33 or similar CVER

type rack configured with an Mk 122 will be susceptible to the same failure modes. Alternate cable routings may eliminate or reduce these failures.

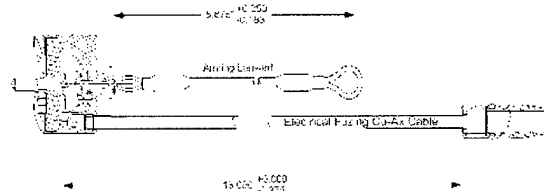
Fuze charge time can be adversely effected by the specified tolerances figure 11, of the lanyard and co-axial cable. Fuze charge time is directly related to the difference between the arming lanyard and co-ax cable length a nominal 7.175". The original tolerances were developed for low ejection velocities. Current operational bomb racks have higher ejection velocities and reaction loads. The worst case occurs with the longest lanyard and shortest co-axial cable. The co-axial cable tolerance allows the cable to be up to -0.375" shorter. The arming lanyard tolerance allows the cable to be up to +0.250" longer. Stacking these worst-case tolerances yields a worst-case tolerance stack of 0.625 inches. This tolerance stack can decrease available fuze capacitor charge time by as much as 10% (2.4ms) based on an Mk 82 nominal ejection velocity of 22ft/sec. Fifteen milliseconds are required for full FMU-139 charge. Therefore a limited margin exists in the current switch design for high ejection velocities [or rack dynamics].

Figure 11
Mk 122 Switch Arrangement

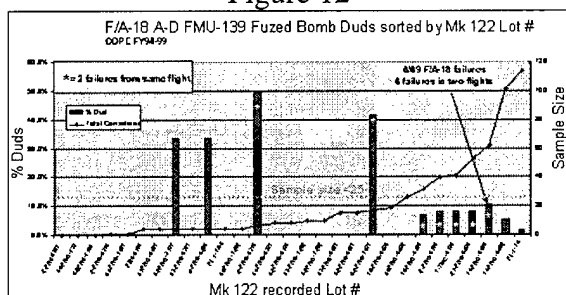
Figure 12

The majority of Mk 122 inventory is almost 30 years old. Switch function may be impaired by lubricant used in the switch that has degraded and migrated into areas of the switch it was not intended for. Original tests designed to verify the switch performance are no longer valid due to sticking brought about by age. Limited on-aircraft F/A-18 & AV-8B ground tests of two switch lots identified switch closure times in excess of the specification time of 2.5ms. Mk 122 Lot FII was greater than 4-5 ms and Lot TMC was greater than 7-7.5 ms. Switch delays reduce fuze charge time margin. Analysis of COPE data, figure 12, did not identify any particular critical lots of Mk 122 Safety Arming Switches.

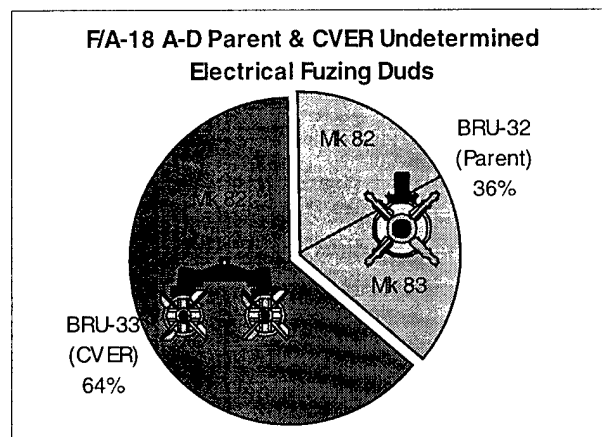
Figure 13

The BRU-32 and BRU-33 have some of the highest ejection velocities of current operational Navy bomb racks. From the analysis of Navy COPE data, figure 13, it was determined that 64% of the F/A-18 undetermined duds occurred when bombs were released from the CVER. Parent station undetermined duds were evenly split between Mk 82 and Mk 83 bombs. The COPE data sample for CVER was made up mainly of 500lb Mk 82 Bombs.

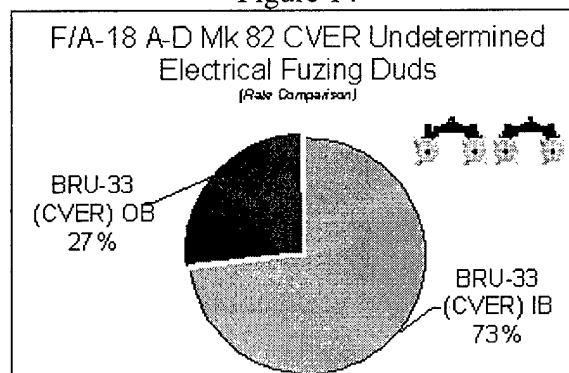
Figure 14

The largest percentage of undetermined duds from the CVER occurred from the inboard CVER station, figure 14 that is the second bomb to be released from the CVER.

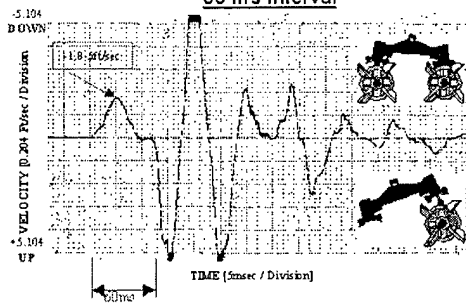
The CVER ejection dynamics are the greatest when only one store is loaded on the CVER as shown in figure 15. Ejector piston reaction loads force the CVER to pivot away from bomb as seen in figure 16. The reaction loads pivot the BRU-33 to an elevated displacement after the first bomb has already been released. In this configuration a roll rate is also imparted into bomb by the BRU-33 ejector feet. The combination of these dynamics shortens the time between lanyard pull and umbilical disconnect.

Figure 15
CVER Velocity During Ejection
60 ms Interval

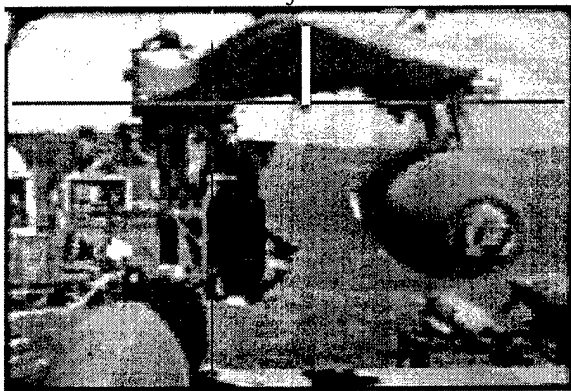
Figure 16
Mk 82 CVER Ejection @ 60 ms

It can also be shown from ground test data that CVER ejection dynamics change as a function of the release interval. The combination of CVER ejection dynamics and the roll rate imparted into the bomb reduce the Mk 122 co-axial cable connect time to the point where a bomb dud can occur for both 500 and 1000lb bombs on the CVER.

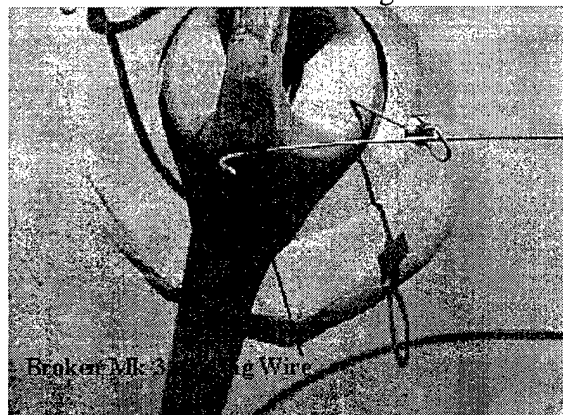
Several bomb failure modes have been attributed to the Mk 3 arming wire. First, the routing of the arming wire around the bomb lug makes it susceptible to damage if it becomes jammed between bomb rack hook and lug during loading, in-flight carriage, separation, and downloading as shown in figure 19.

Figure 19
Broken Mk 3 Arming Wire

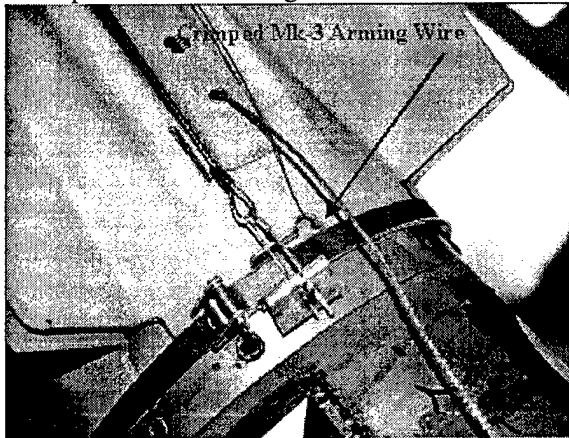
Figure 20

Another failure mode of the Mk 3 arming wire occurs when used in conjunction with the Mk 82 BSU-86 Tail Fin. The fin blade movement of the BSU-86 can cut or kink the wire during carriage as shown by figure 20. This failure mode has also been reported on Mk 15 fins.

Crimped Mk 3 Arming Wire on BSU-86 Fin

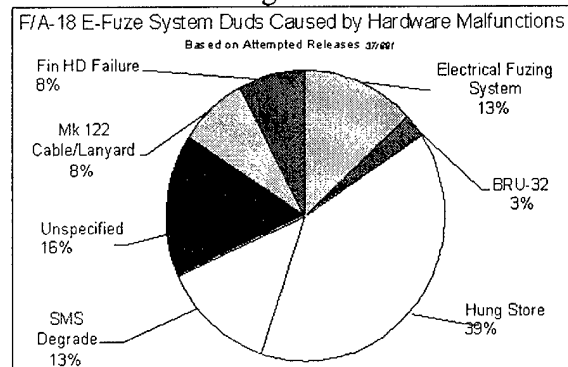
Figure 26

Hardware malfunctions were reviewed and sub divided into categories in figure 26. A few of these subcategories require further amplification. As previously stated Mk 122 cable/lanyard failure evidence is easily lost after weapon release in a test environment and even more so in an operational scenario. It is suspected that this failure occurs more frequently and is contained in the 4.4% undetermined dud category. Next, of the reported hung stores, 87% occurred in one Fiscal year, (FY 98) and 53% were attributed to two aircraft. Finally, of the majority of the SMS degrades, 80% occurred on the same acft.

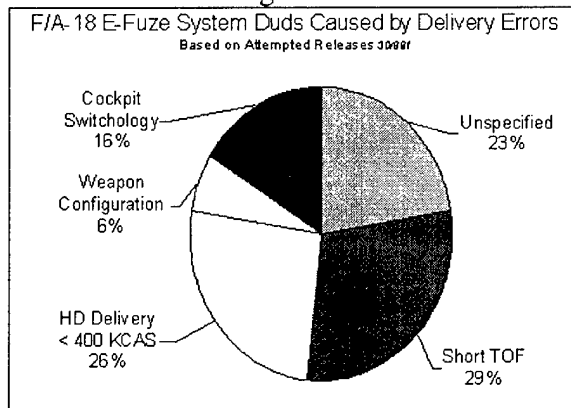
Figure 27

Delivery errors were reviewed and separated into categories in figure 27. Short time of fall (TOF) and delivery of high drag weapons at less than 400 KCAS account for the majority of delivery errors. Short TOF duds can occur prior to receipt of a dud cue. A dud cue is displayed on the heads up display (HUD) when the fuze arm time is greater than the aircraft calculated weapon time of fall. The time of fall for dud cue generation however does not account for fuze arm time tolerances. Therefore a short TOF dud can occur even though no dud cue is generated.
